STAGE I SUMMARY T	ECHNICAL MEMORANDUM
	Moline Street PCR Site

Attachment A
Asbestos Buil ding Inspection Report - 2/24/2014

STAGE I SUMMARY TECHNICAL MEMORANDUM  Moline Street PCB Sin	M te
DRILLING RECORDS AND BORING LOGS

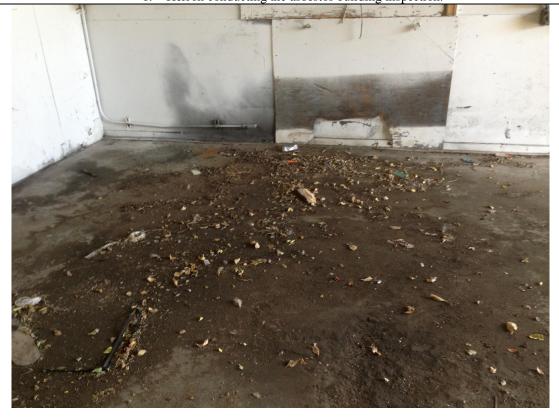
2. Wipe sampling location B-F1-0 on the floor of Building B.

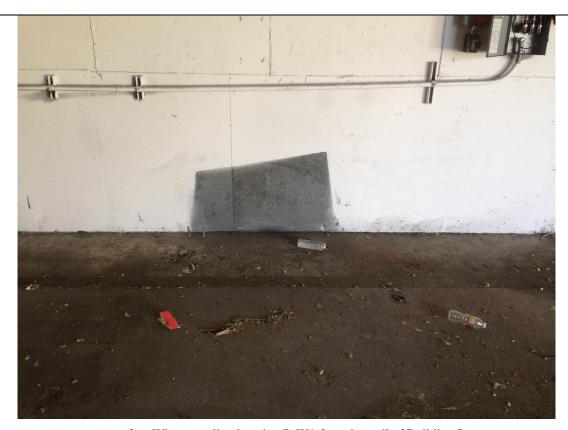
3. Wipe sampling location B-W1-2 on the wall of Building B.

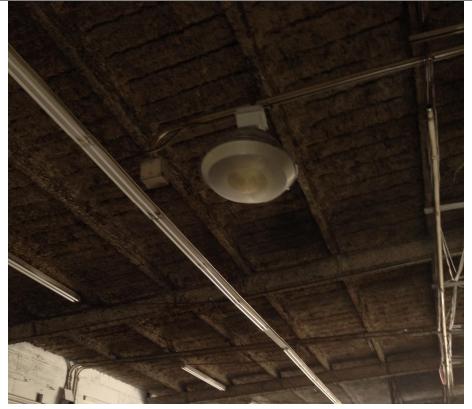
4. Wipe sampling location B-C1-13.5 on the ceiling of Building B.

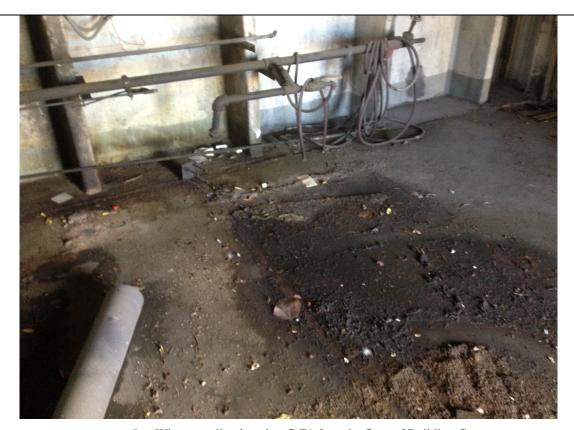
5. Wipe sampling location C-F1-0 on the floor of Building C.

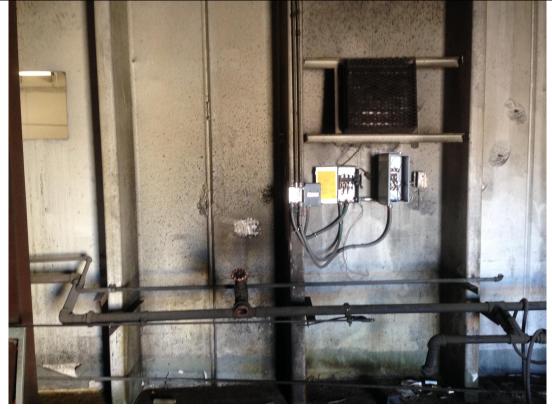
6. Wipe sampling location C-W1-4 on the wall of Building C.
